(c) NATIONAL PHOTOGRAPHIC INTERPRETATION CENTER

ATTACHMENT TO M-6062 20 MARCH 1969 PAGE 1

HOA LAC AIRFIELD NORTH VIETNAM 2101N 10530E

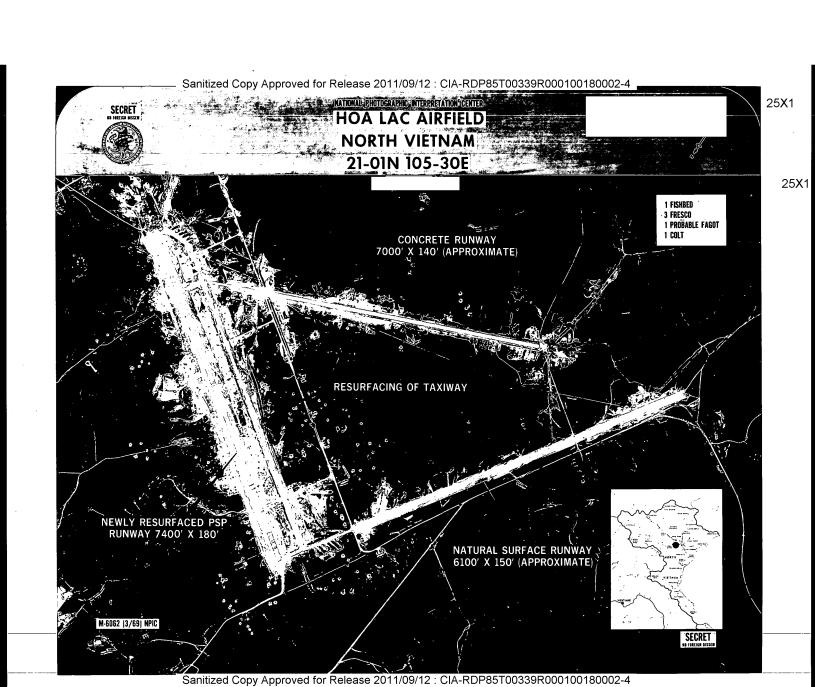
THIS BRIEFING BOARD DEPICTS THE RECENTLY COMPLETED RESURFACING OF THE MAIN RUNWAY, WITH PROBABLE RESURFACING OF THE PARALLEL TAXIWAY IN PROGRESS.

THE MAIN (NW/SE) RUNWAY HAS BEEN RESURFACED WITH PROBABLE PSP. A CENTER SECTION OF THE PARALLEL TAXIWAY IS APPARENTLY BEING RESURFACED WITH PROBABLE PSP.
